PEARCE CREEK DREDGED MATERIAL CONTAINMENT FACILITY EXTERIOR MONITORING PROGRAM FALL 2019 POST-PLACEMENT RESULTS

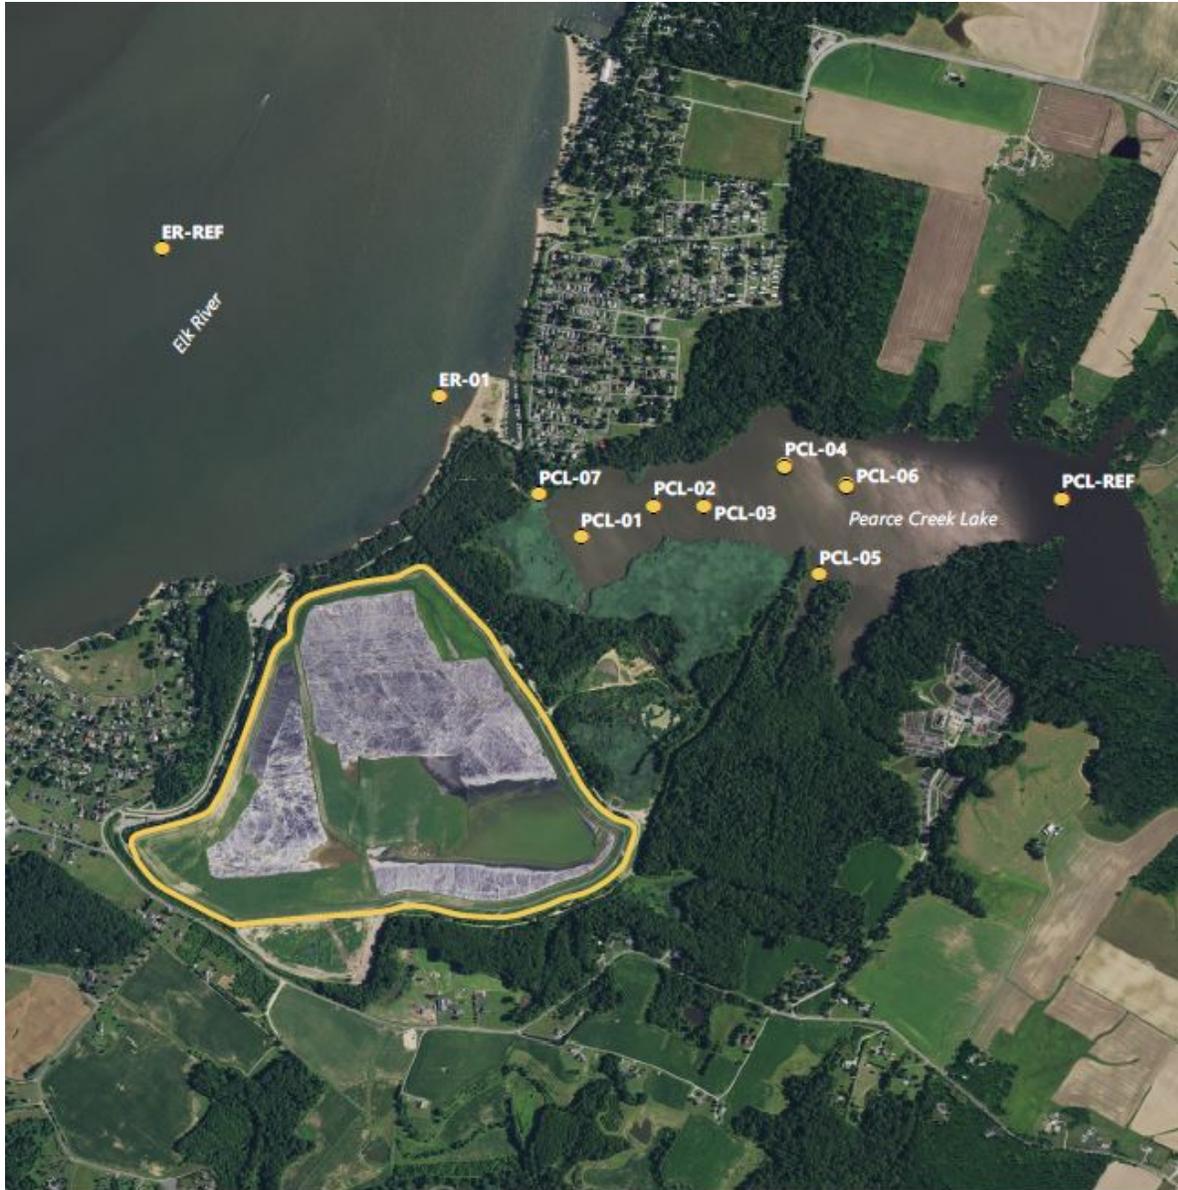
FIGURE 1. EXTERIOR MONITORING LOCATIONS

This data summary details the results of the fall 2019 post-placement monitoring event, which was conducted in September 2019 and included sample collection from seven monitoring locations and one reference location in Pearce Creek Lake, and one monitoring location and one reference location in the Elk River (Figure 1). Reference locations measure natural changes in background conditions and are located in areas that are outside of the influence of the DMCF operations. Results from the reference locations are compared to the results from the monitoring locations to evaluate if inputs from the surrounding watershed may be influencing conditions in Pearce Creek Lake or the Elk River.

Eight surface water samples were collected from Pearce Creek Lake, and two surface water samples were collected from the Elk River (Figure 1). In addition to measuring the surface water conditions when the samples were collected—such as water temperature, oxygen content, and water clarity (turbidity)—the surface water samples were also sent to a certified laboratory. Laboratory tests for the water samples included metals, phosphorus, nitrogen, ammonia, and suspended solids. This list was chosen to represent the composition of surface water runoff and soil erosion, which provide the majority of the surface water that flows into Pearce Creek Lake from the surrounding area.

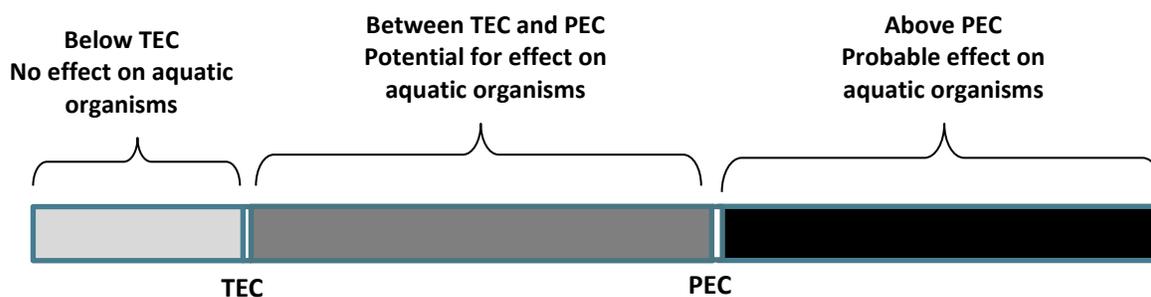
FIGURE 2. DATA EVALUATION USING SEDIMENT QUALITY GUIDELINES

Sediment quality guidelines are used to identify potential chemicals of concern in aquatic ecosystems. The threshold effect concentrations (TEC) are chemical concentrations below which adverse effects on organisms are unlikely. Probable effect concentrations (PEC) represent concentrations above which adverse effects on organisms are possible. Concentrations that are between the TEC and PEC represent the concentrations at which adverse effects on organisms may occur, as shown in Figure 2:

Comparisons of chemical concentrations in sediment from the Pearce Creek Lake monitoring locations to the TECs and PECs indicated that five metals were detected at concentrations between the TEC and PEC, and only nickel was detected at a concentration that exceeded the PEC value. Nickel exceeded the PEC for most of the Pearce Creek Lake monitoring locations and the reference site. However, the nickel concentrations are within the range of concentrations observed during the baseline sampling, so environmental conditions have not changed compared to the pre-placement condition. Nickel is typically detected at concentrations that are slightly above the PEC throughout the Chesapeake Bay region due to the underlying geology in the area.
